*San Francisco–Oakland Bay Bridge  
East Span Seismic Safety Project*

FINAL SFOBB Pier E3 Implosion Demonstration Project Report

**May 2016**

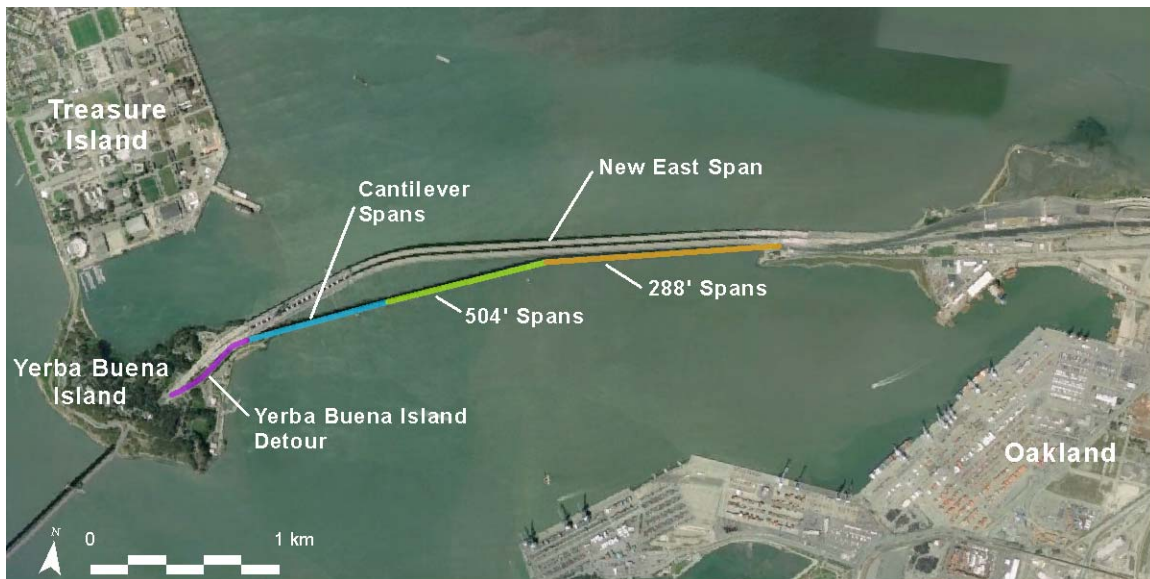
**Figure 3. Sections of the Original SFOBB East Span**

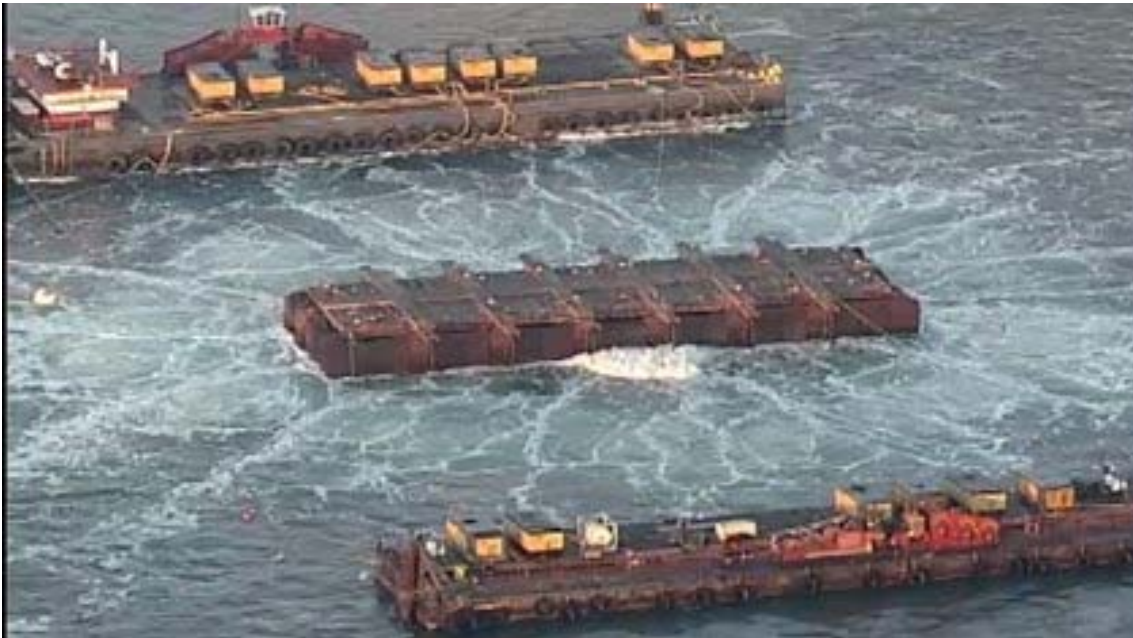
**Figure 15. BAS Operating before the Implosion**

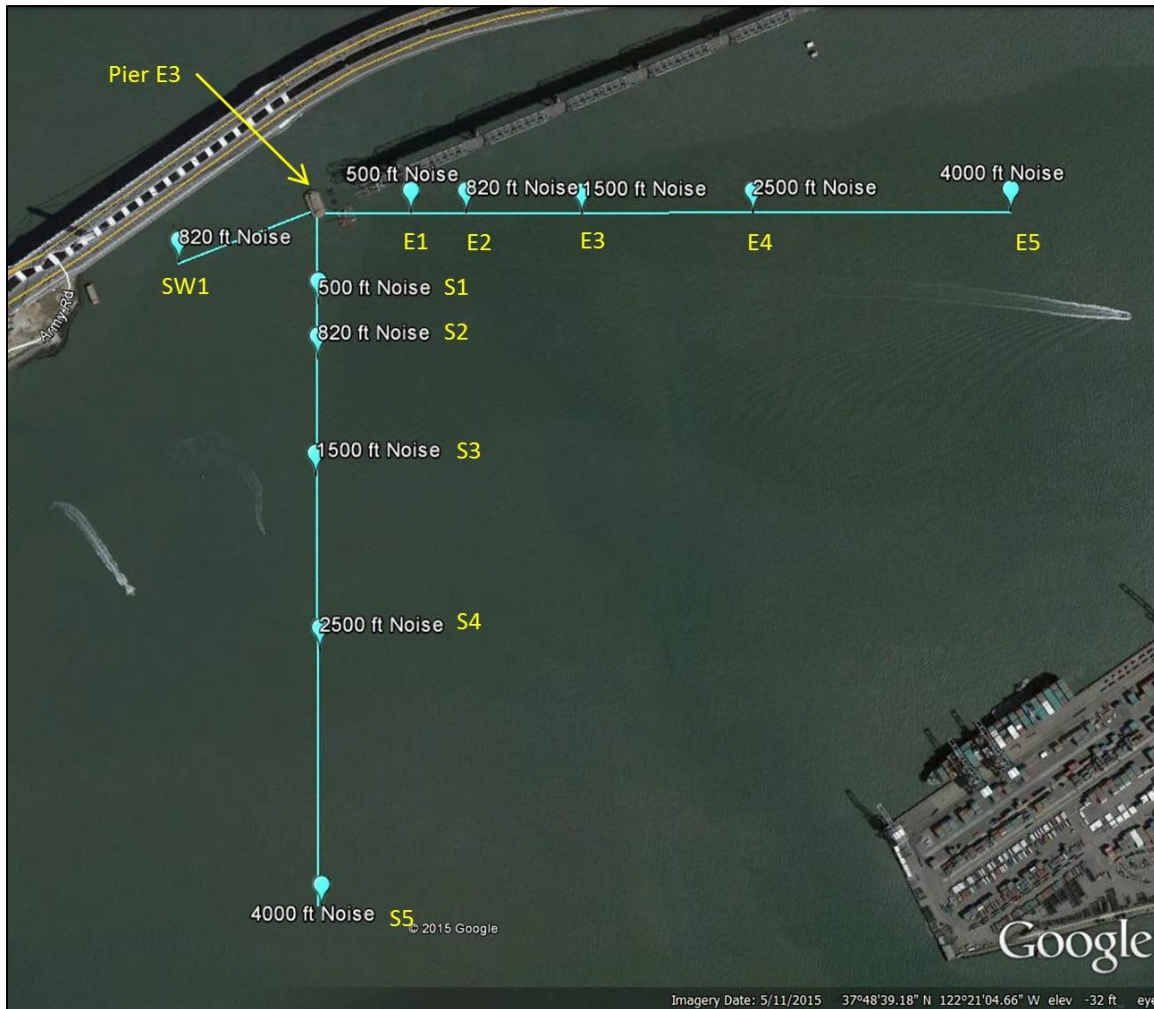
**Figure 31. Proposed and Deployed Locations of All Far Field Monitoring Points**

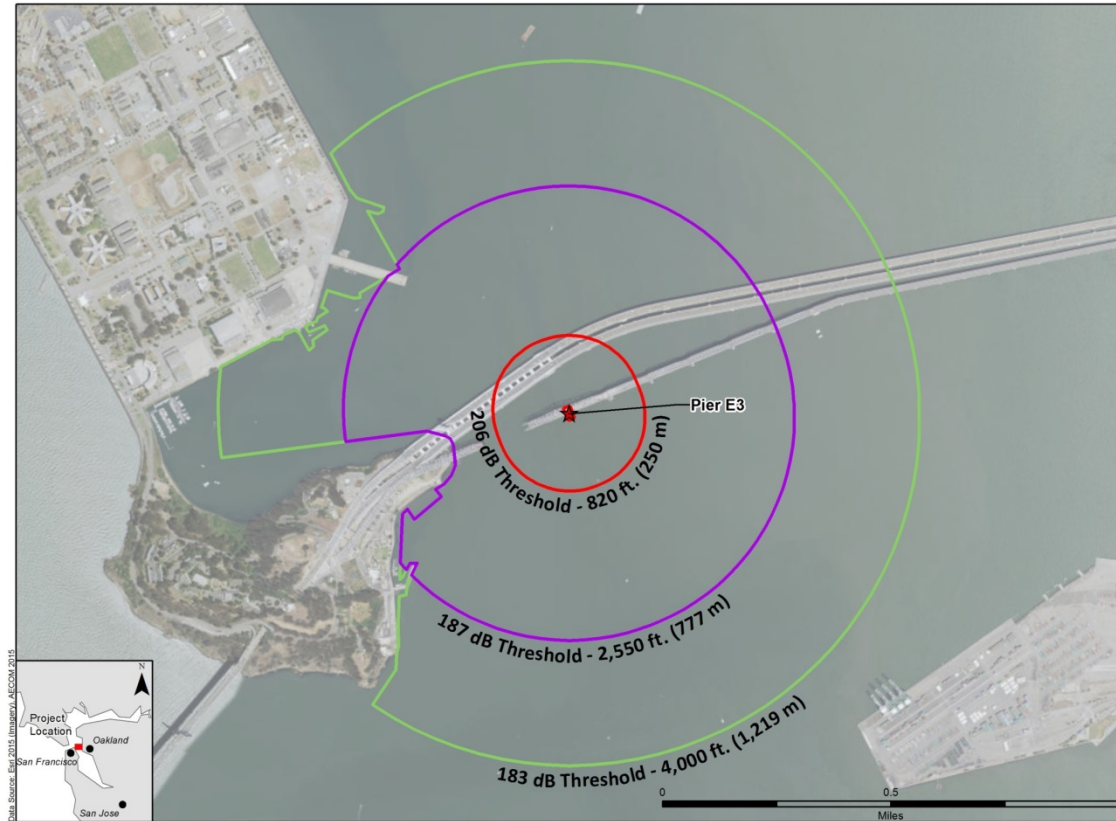
**Figure 63. Modeled Isopleths to Fish Threshold Criteria**

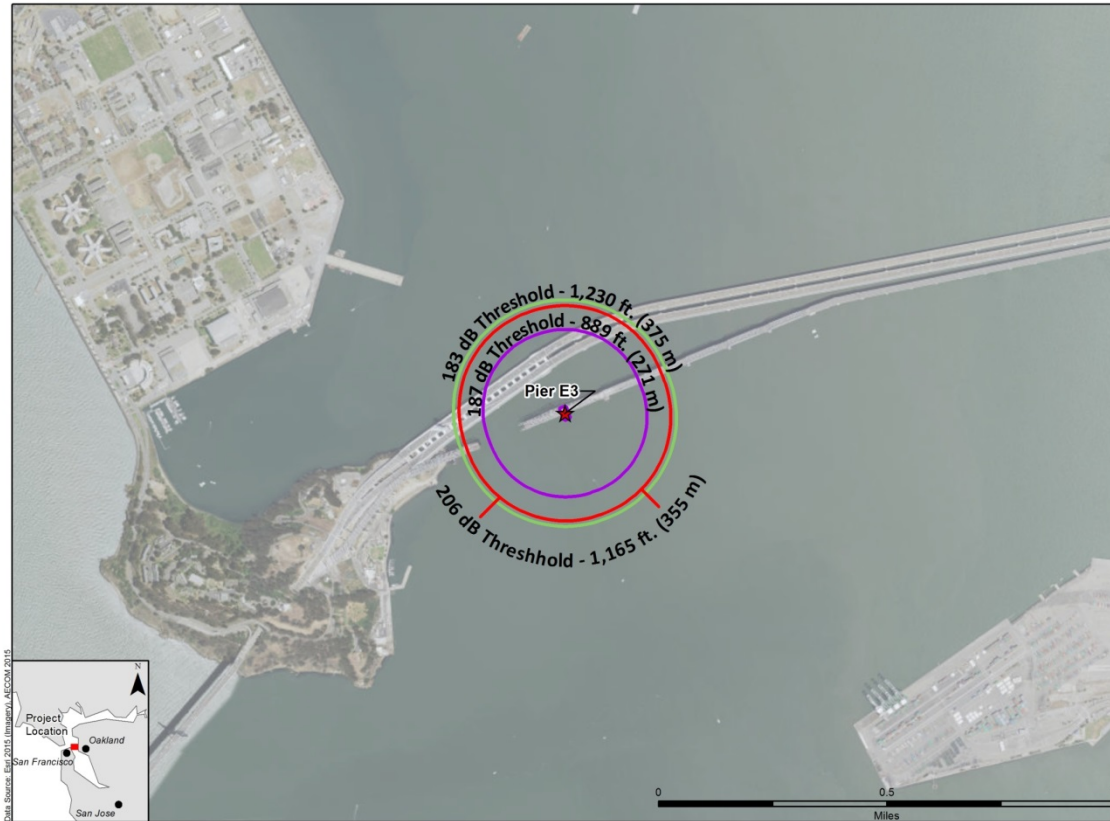
**Figure 64. Measured Isopleths to Fish Threshold Criteria**

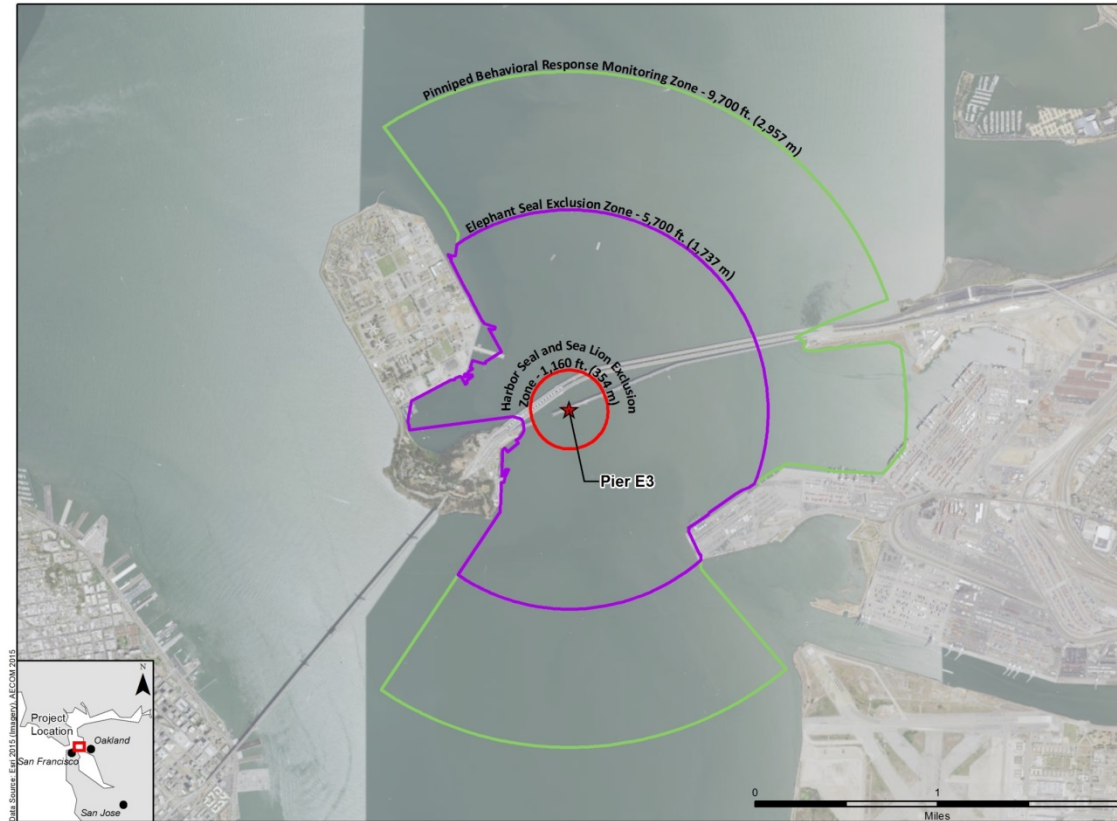
**Figure 65. Modeled Isopleths to Pinniped Threshold Criteria**

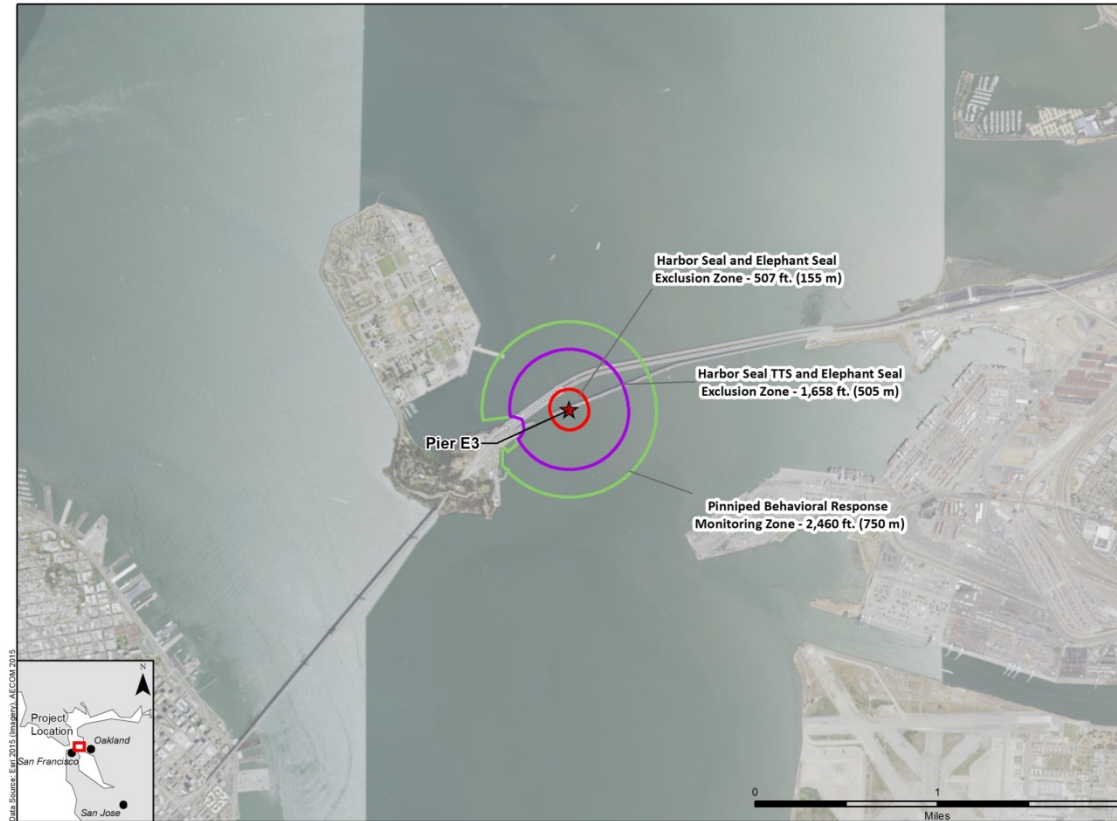
**Figure 66. Measured Isopleths to Pinniped Threshold Criteria**

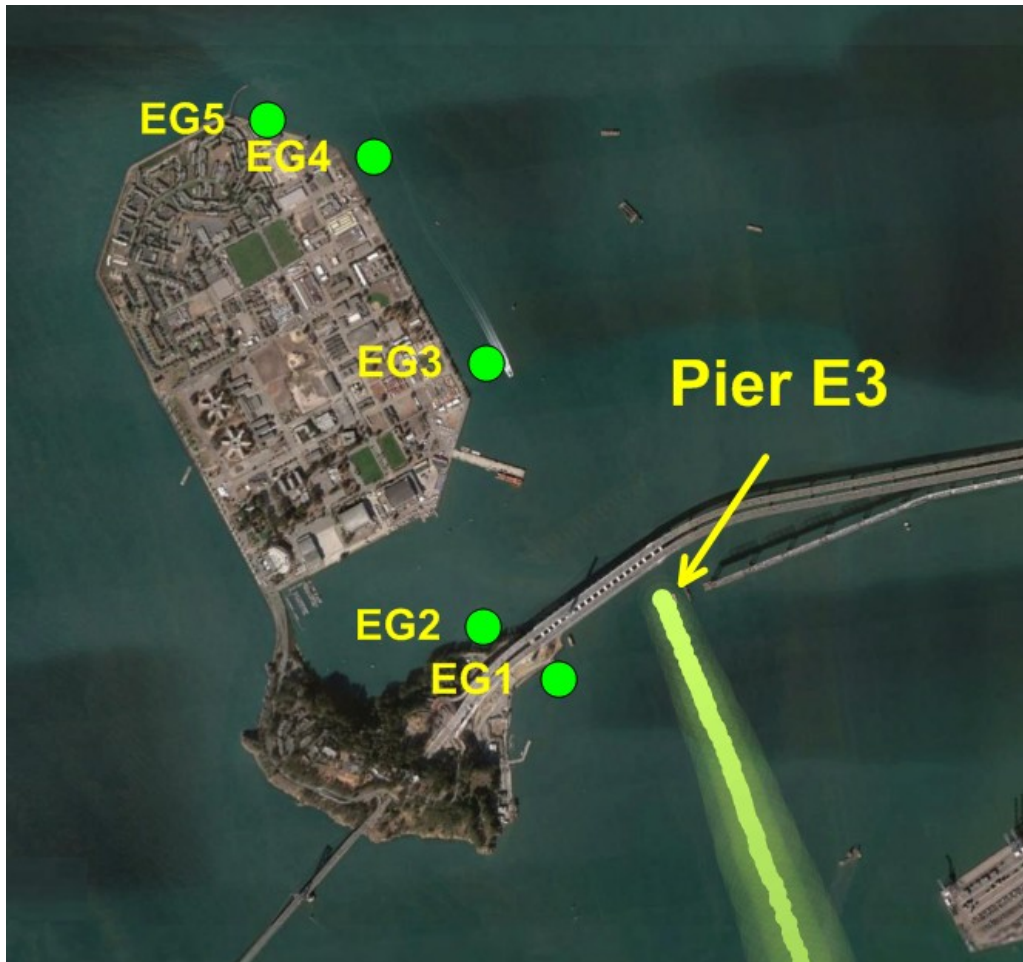
**Figure 69. Location of Eelgrass Monitoring Buoys**
